**Morgantown Road House**  
**CH-723**  
**Morgantown vic.**  
**Private**

**C. 1900**

## Maryland Inventory of Historic Properties Form

Inventory No. CH-723

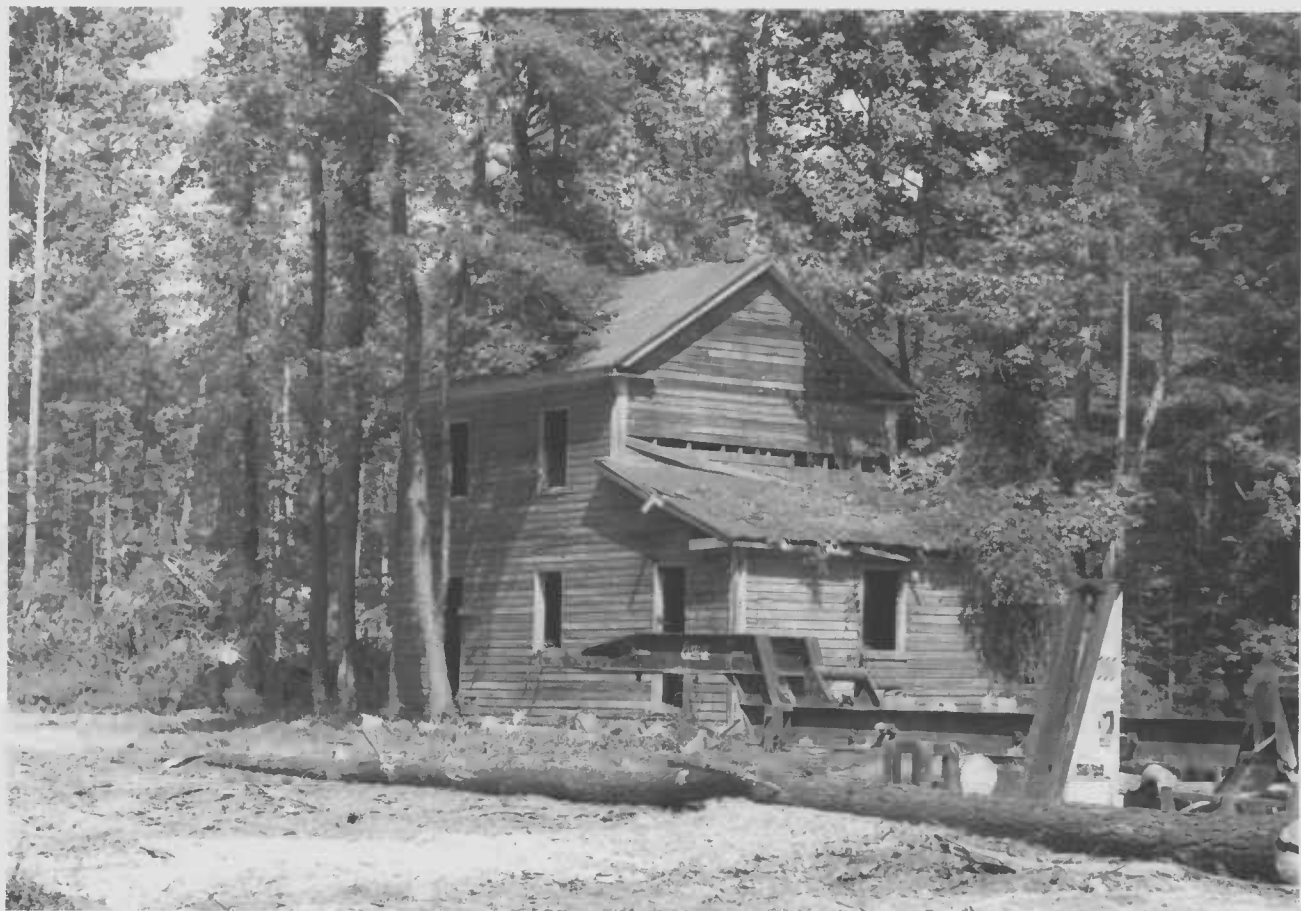
CH-723  
MORGANTOWN ROAD HOUSE  
CHARLES @. MD  
C. CURREY/  
2/2001  
MD SHPO  
LOOKING NW  
1 OF 2

The Morgantown Road House, demolished soon after being field surveyed, was a two-story, two bay frame dwelling on the north side of Morgantown Road. Abandoned for some time, the house faced south and stood slightly removed from the roadside. An original one story ell extended from the east elevation. Although all windows and doors had been removed long before the property was evaluated, the original exterior finishes including novelty siding remained intact. Although overtly simple in design, the dwelling had some decorative finishes including a boxed cornice, eave returns and corner boards. A single interior end chimney flue was placed in the main block, near the east wall.

The façade was symmetrical with a first floor doorway to the west and a window to the east. Above this were placed two second story windows. The rear elevation included only two first floor windows. The west elevation was without fenestration. The ell included a doorway on the façade, a single centered window on the east wall and a doorway at the rear.
